IEPA - BOW - Peoria

Inspection Report

Pork Hill Farm CAFO Inspection

May 2, 2012

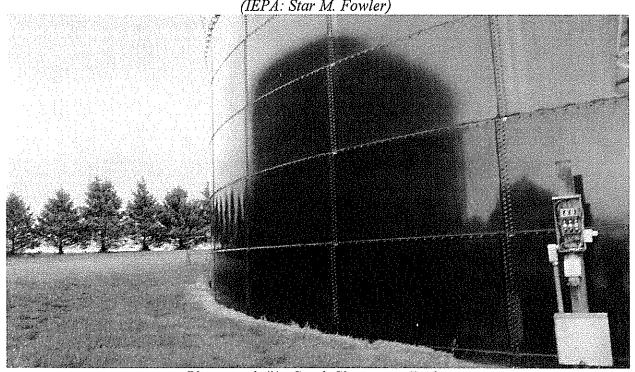
The South Slurry tank had liquid manure removed and land applied this March. Approximately 600,000 gallons of liquid manure were removed.

Photograph #1. South Slurrystore Tank.

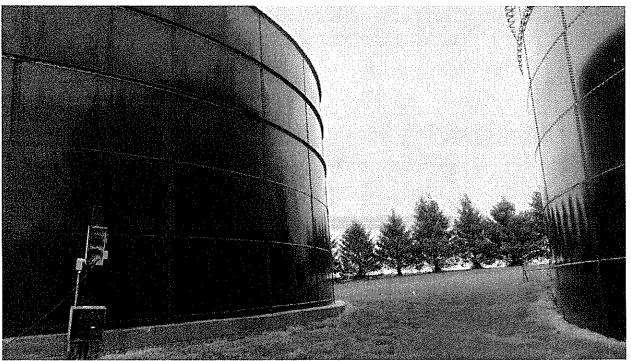
Photograph #2. Both Slurrystore Tanks shown. View is east.

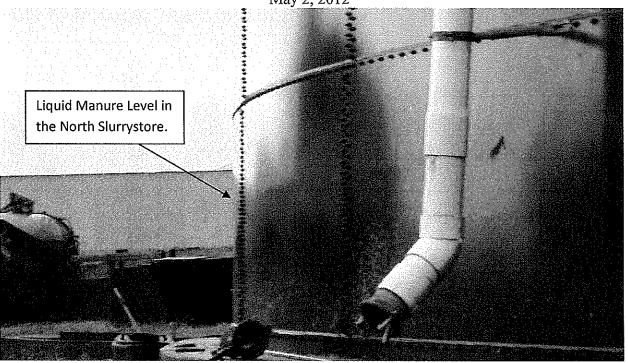
During the inspection the North Tank had less than 1 full ring or approximately 2.5 feet of manure, leaving approximately 17.5 feet of freeboard available. The South Tank had approximately 5 inches less than 2 full rings of manure, leaving approximately 16 feet of freeboard. (Assuming 1 sheet of the slurry tank=~4')

Photograph #3. North Slurrystore Tank ring where liquid level is can be seen.

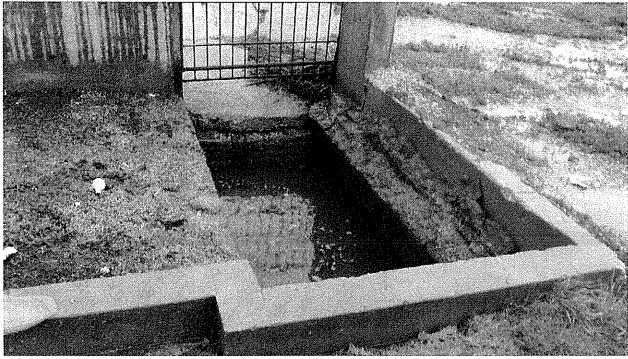
The abandoned feedlot drains all the storm water received to the east towards the reception pit. In an attempt to limit the amount of storm water entering the reception pit a short barrier was installed between the feedlot and the reception pit, see Photograph #5. There were still some areas where the storm water drains from the feedlot into the pit, see Photograph #4.

During the inspection the reception pit (pump station) that collects the liquid manure and discharges the liquid manure into the slurry tanks was observed. The reception pit had approximately 1 foot of freeboard available, see Photograph #4. This reception pit was reported to be approximately 10 feet deep.

Photograph #4. Reception pit (pump station) shown with approximately 1 foot freeboard.

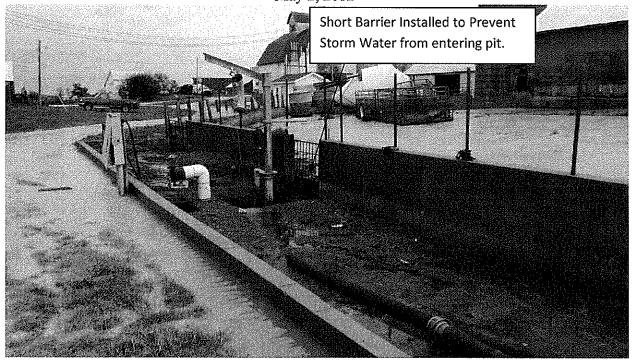
Photograph #5. Reception pit shown with some storm water diversion added.

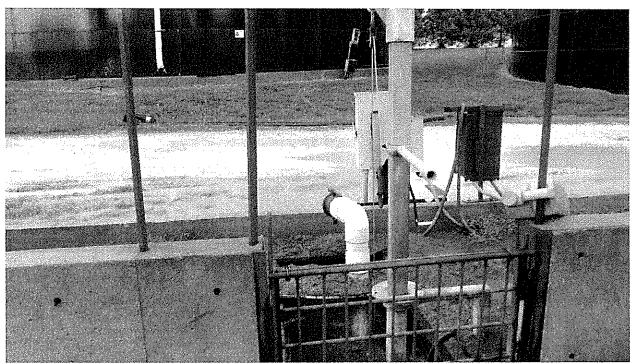
The liquid manure is pumped into either of the two slurry tanks over the top of the tanks using a removable flexible hose line. This hose line must be manually connected to the slurry tank that is going to be filled before pumping can begin. This set up does not appear to cause the facility any management problems at this time.

Photograph #6. Pump for reception pit. Flexible hose in background used to connect pump to the slurry tank before pumping begins.

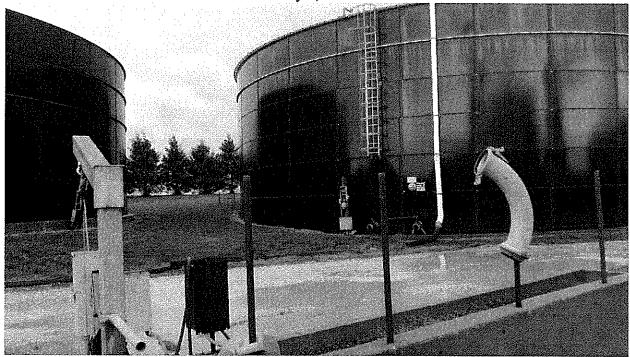
Photograph #7. Foreground reception pit, back ground slurry tank with flexible hose used for filling the slurry tank.

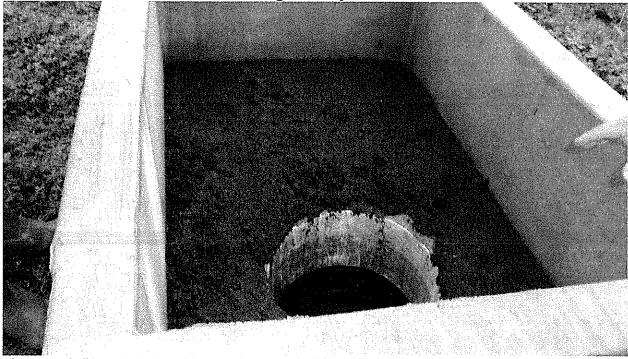
Before the reception pit is a manhole connected with the sewer line that had previously caused liquid manure to be released. During the inspection this approximately 24 inch diameter manhole had a containment tank installed around it. This containment tank extended approximately 2 feet above grade. See Photographs #8-9. There were some manure solids observed inside the containment area, but there was nothing observed that had been released from this containment area.

Photograph #8. Manhole with containment. Solids collecting in containment not being released.

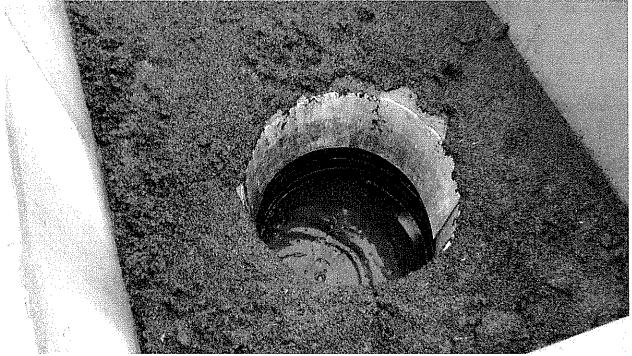
Photograph #9. Manhole with containment, liquid level observed.

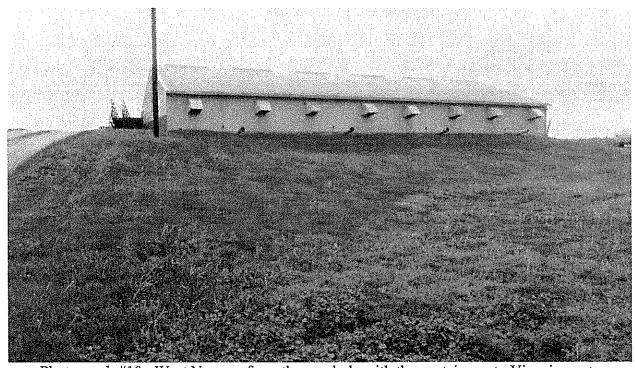
Photograph #10. West Nursery from the manhole with the containment. View is west.

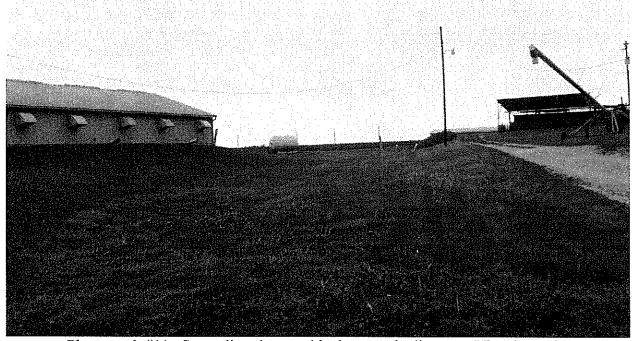
Photograph #11. Sewer line shown with clean-out in distance. View is north.

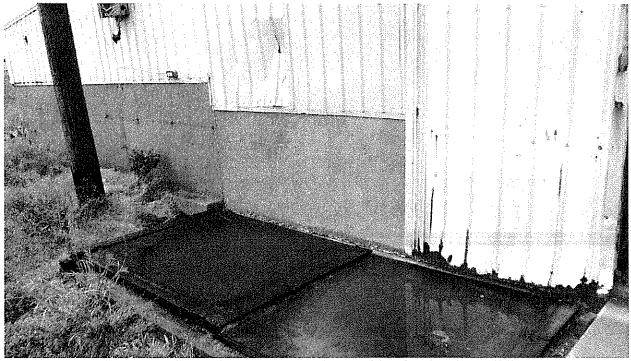
Photograph #12. Pit access on southwest side of Nebraska Building.
